**STATE OF HAWAII
DEPARTMENT OF LAND AND NATURAL RESOURCES
OFFICE OF CONSERVATION AND COASTAL LANDS
Honolulu, Hawaii**

REGARDING: Conservation District Enforcement File MO-08-28
Regarding the Alleged Unauthorized Construction of a
Cement Pad Within Coastal Waters

LOCATION: Submerged State Land
Makai of TMK (2): 5-2-005: 006/019
Moomomi Bay, Hoolehua, Island of Molokai

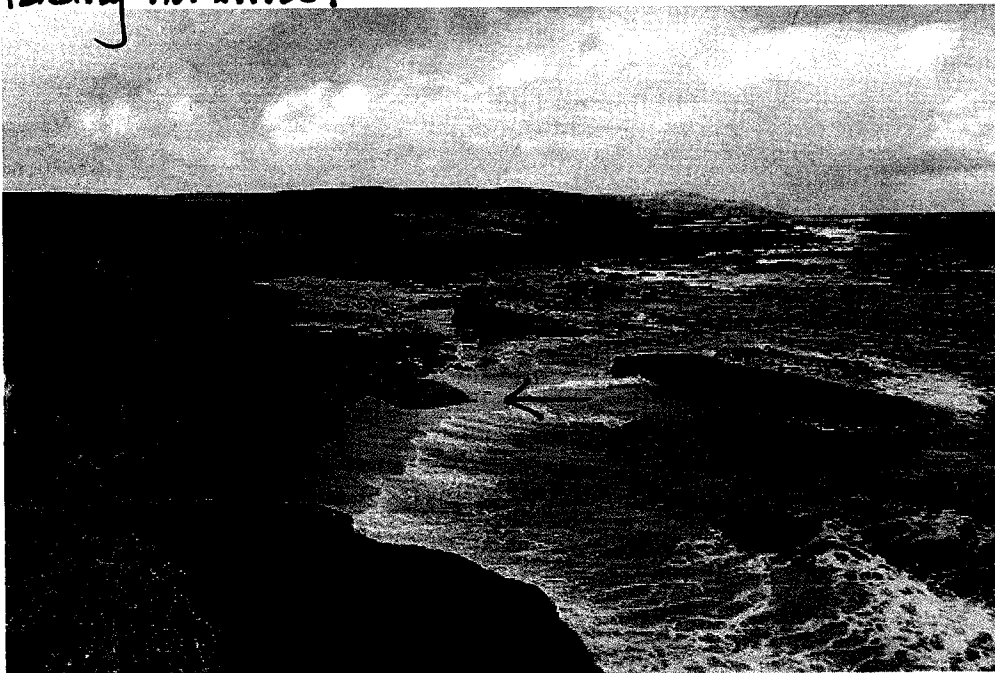
EXHIBIT 2

This region of north Molokai is undeveloped and access is by foot, by sea or by 4-wheel drive vehicle across Hawaiian Homelands. The vehicular access way to the slab appears to be an intermittent stream outlet to the ocean (**Exhibits 1, 2 & 3**).

Facing East

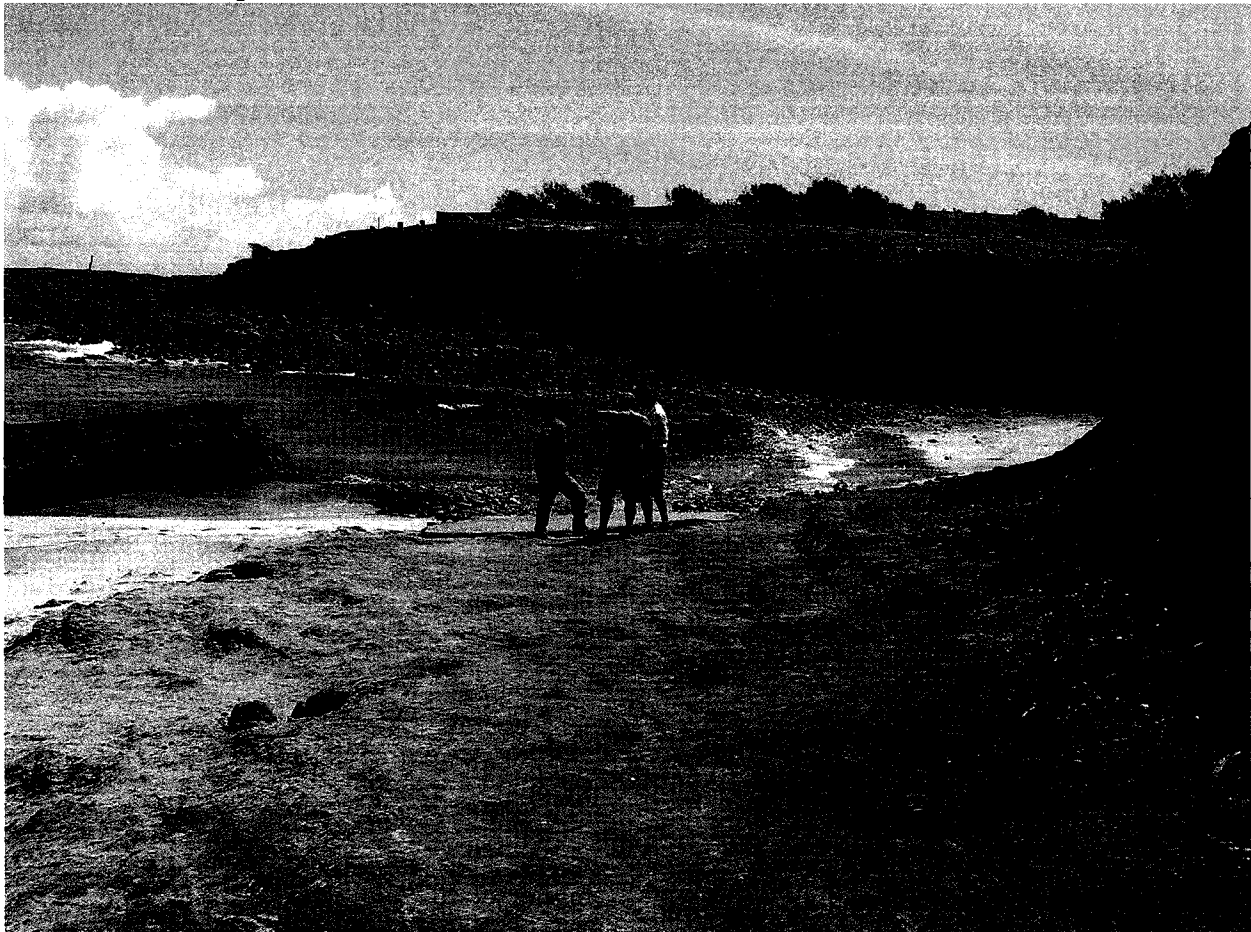
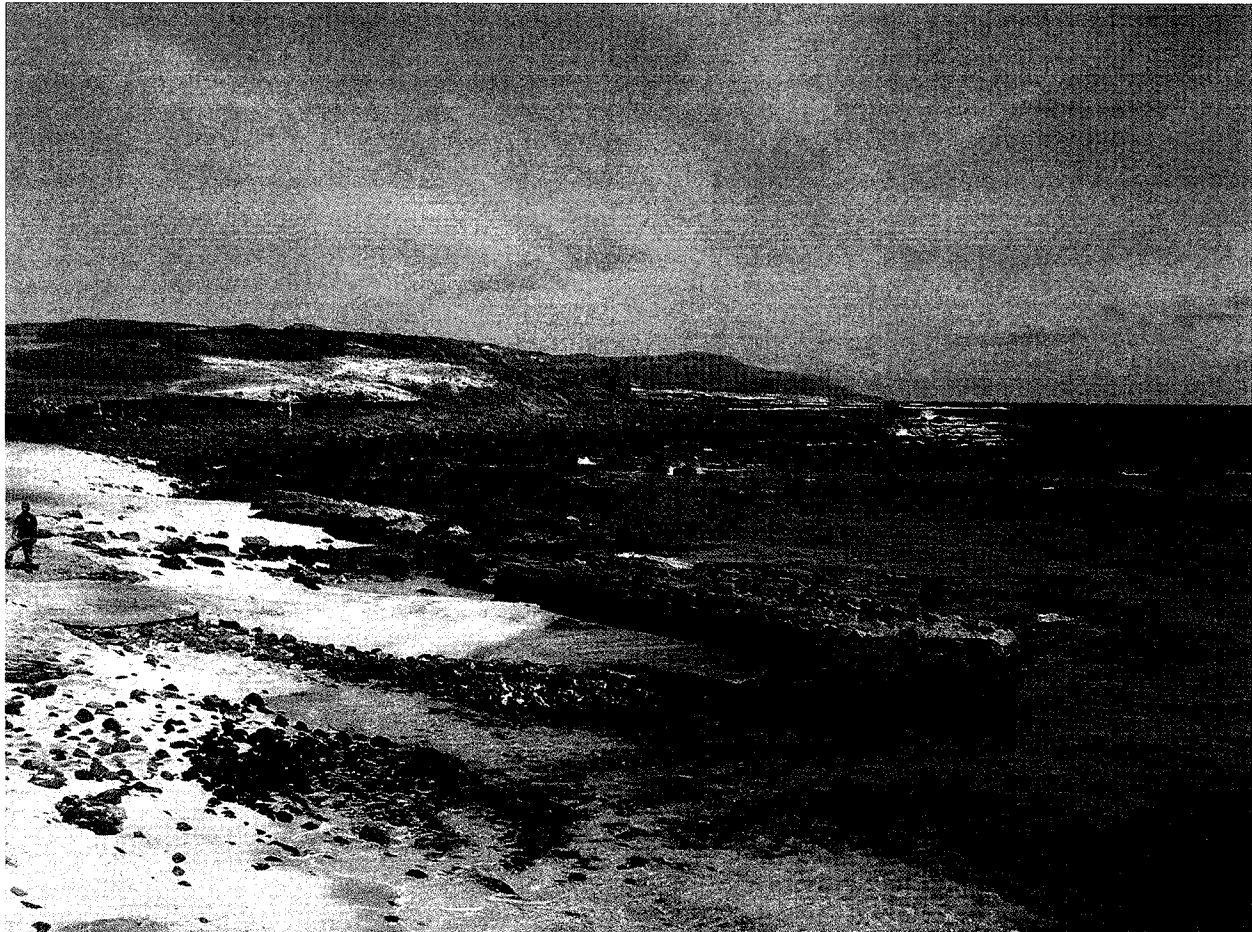
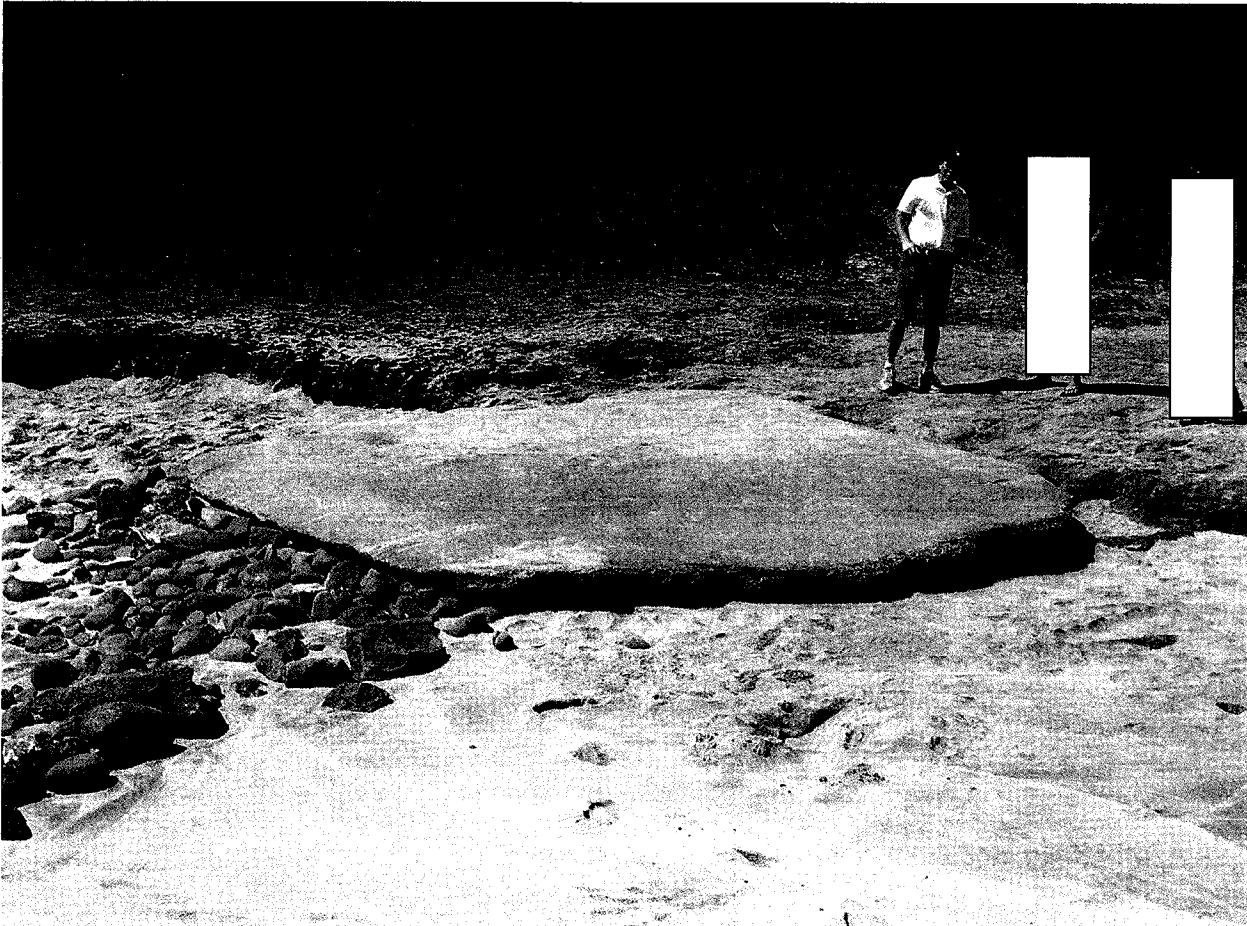
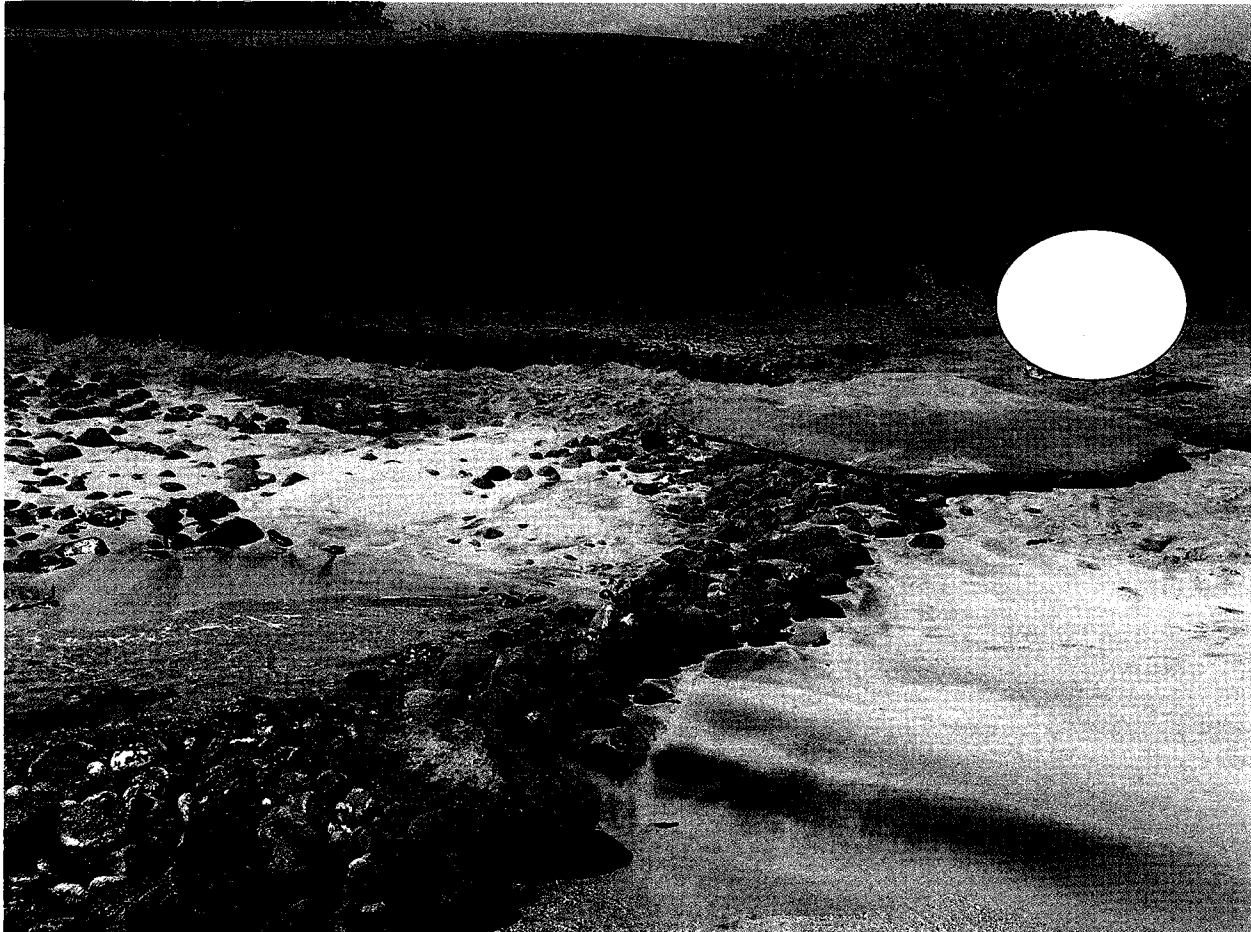
Moomomi site Inspection June 18, 2008

The Office of Conservation and Coastal Lands (OCCL) began receiving several complaints in 2008 regarding the existing cement slab in the shoreline at the subject location. A site inspection of the subject area was conducted by the OCCL on the morning of June 18, 2008. The slab is described as being $\approx 150 \text{ ft}^2$ and created with rebar and wire with a depth of ≈ 4 -feet. According to information gathered, the alleged unauthorized land use has been utilized as a boat launch for fishermen (**Exhibit 4, 5 & 6**).

The cement slab appears to lie makai of the shoreline as evidenced by sand deposits mauka of the slab. The slab and immediate vicinity appears to be maintained as area rocks have been moved to define the pathway for ocean entry and to reinforcement the slab. Affects to the beach resource appear to be minimal and localized to adjacent areas of the slab.

However, Staff recommends that Hui Malama O Moomomi, be found in violation of Chapter 183C, HRS and either remove the structure or apply for an after the fact Conservation District Use Application for the encroaching structure.

4. That within 180 days of the date of the Board's action, Hui Malama O Moomomi shall either remove the structure or file for an after the fact Conservation District Use Application for the cement slab;

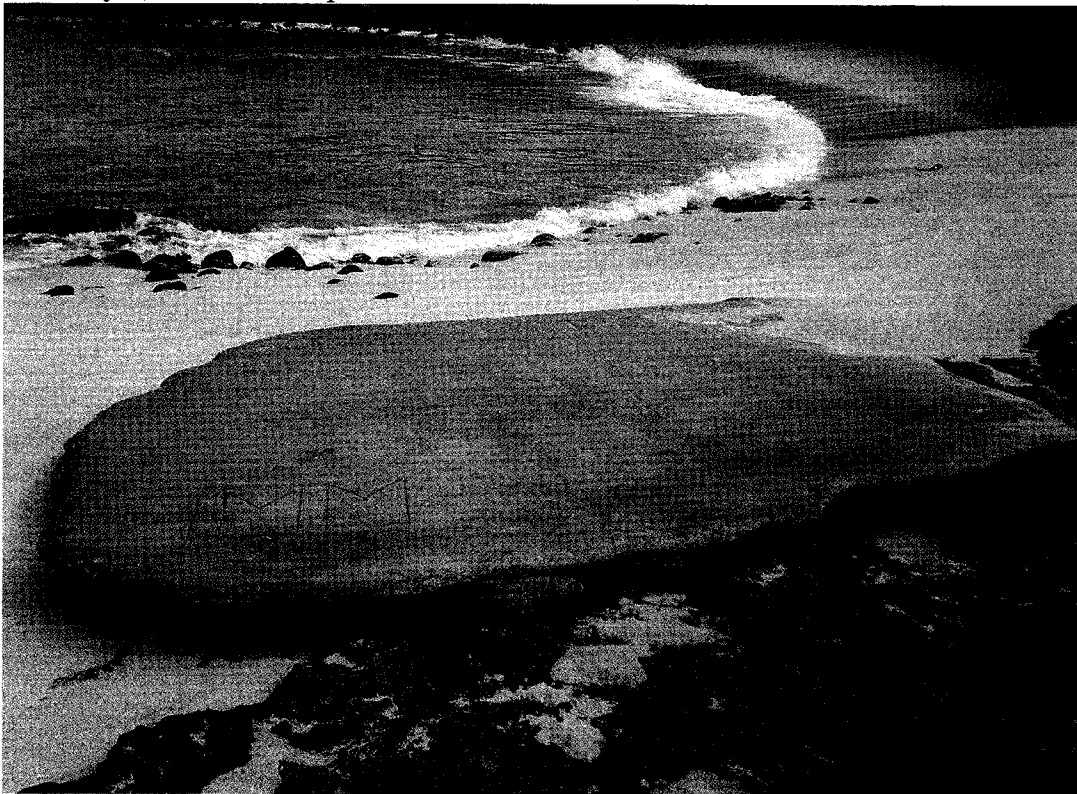
February 5, 2008 Site Inspection

This photograph depicts a concrete slab at Moomomi. Moomomi Bay in background.
